# XPR LAGUNA SOUND

→ 20MIL  
WEAR LAYER

## XPR LAGUNA SOUND

## TECHNICAL DATA

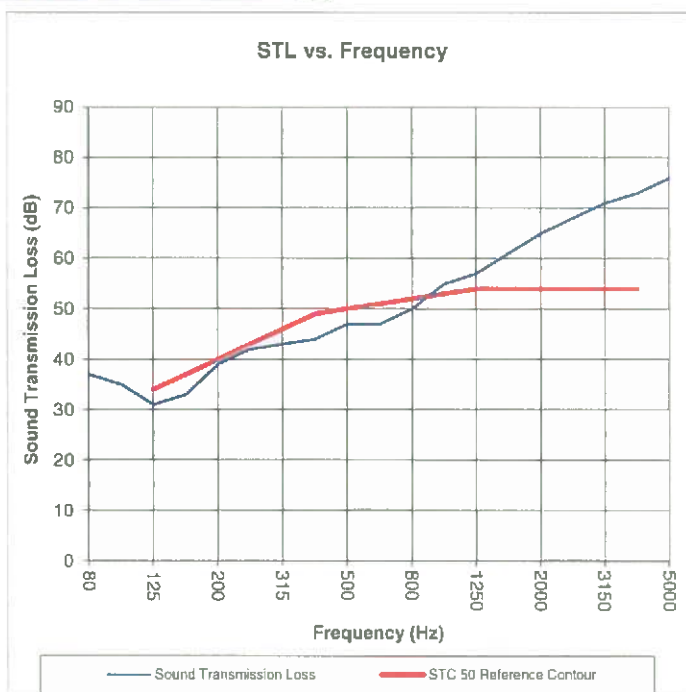
\* Due to high insulating value of specimen, background levels limit results at these frequencies.

STL = Sound Transmission Loss, dB  
 Δ STL = Uncertainty for 95% Confidence Level

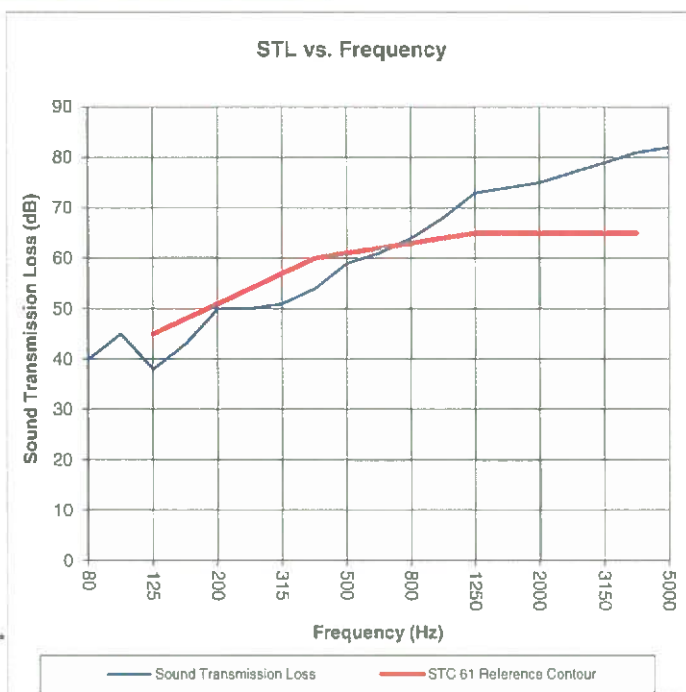
\* Due to high insulating value of specimen, background levels limit results at these frequencies.

STL = Sound Transmission Loss, dB  
 Δ STL = Uncertainty for 95% Confidence Level

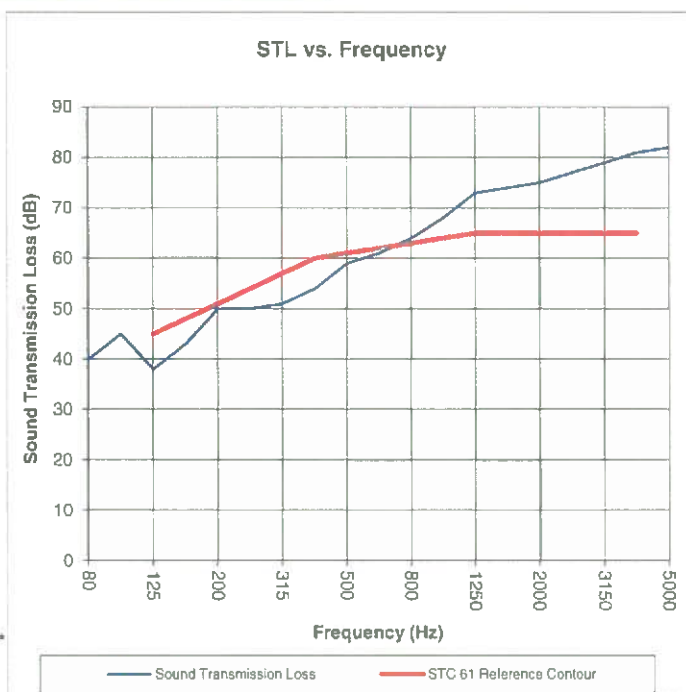
\* Due to high insulating value of specimen, background levels limit results at these frequencies.

STL = Sound Transmission Loss, dB  
 Δ STL = Uncertainty for 95% Confidence Level

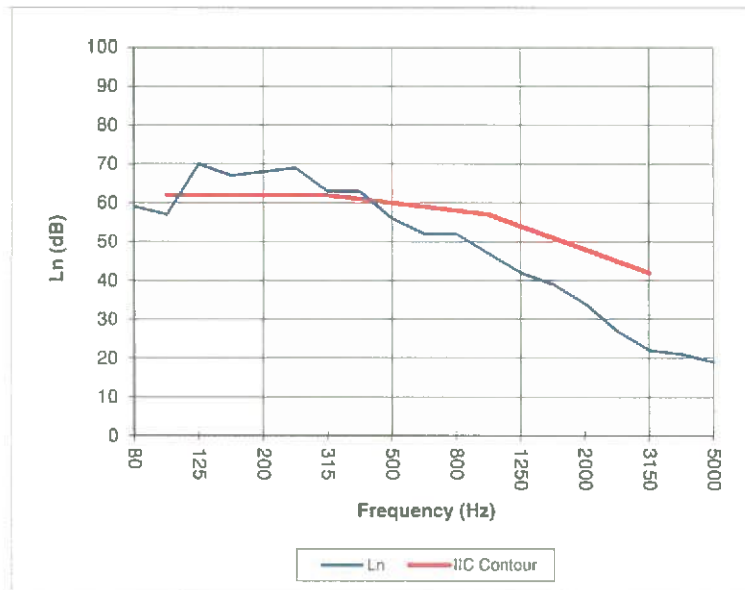
\* Due to high insulating value of specimen, background levels limit results at these frequencies.

L<sub>n</sub> = Normalized Sound Pressure Level, dB

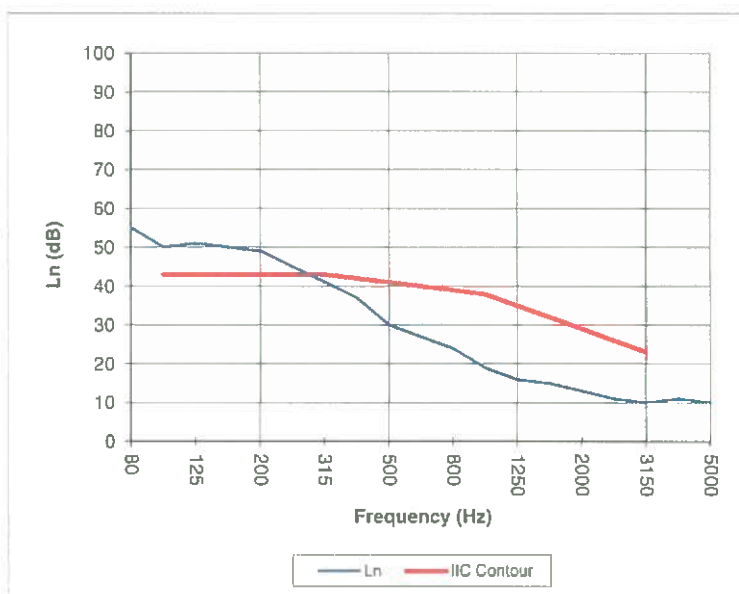
\* Due to high insulating value of specimen, background levels limit results at these frequencies.

L<sub>n</sub> = Normalized Sound Pressure Level, dB

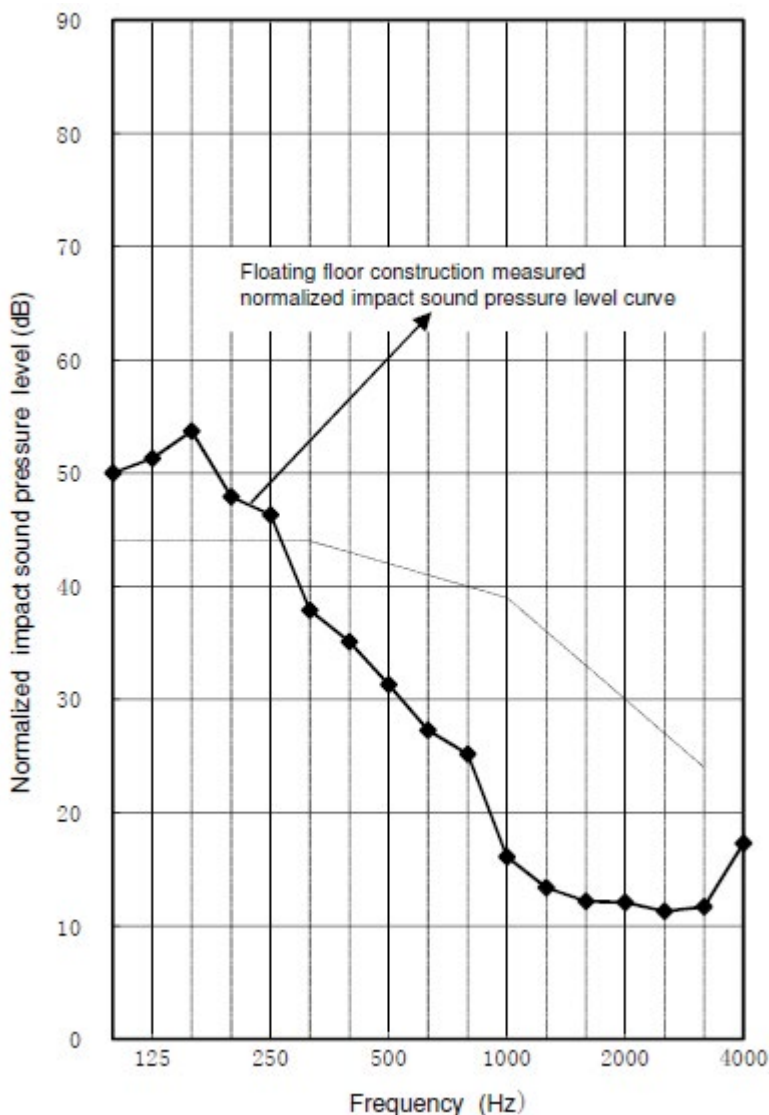
| f<br>Hz | Ln<br>dB |
|---|---|
| IIC | 66 |

Remark:  $L_n$  as the weighted normalized impact sound pressure level

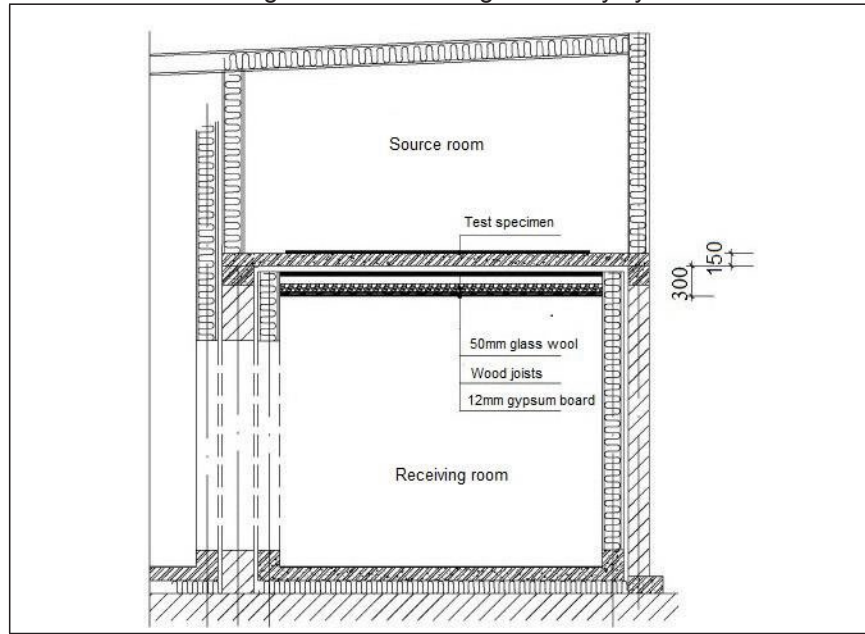
### Appendix 2: The constructional drawing of the floor/ceiling assembly system

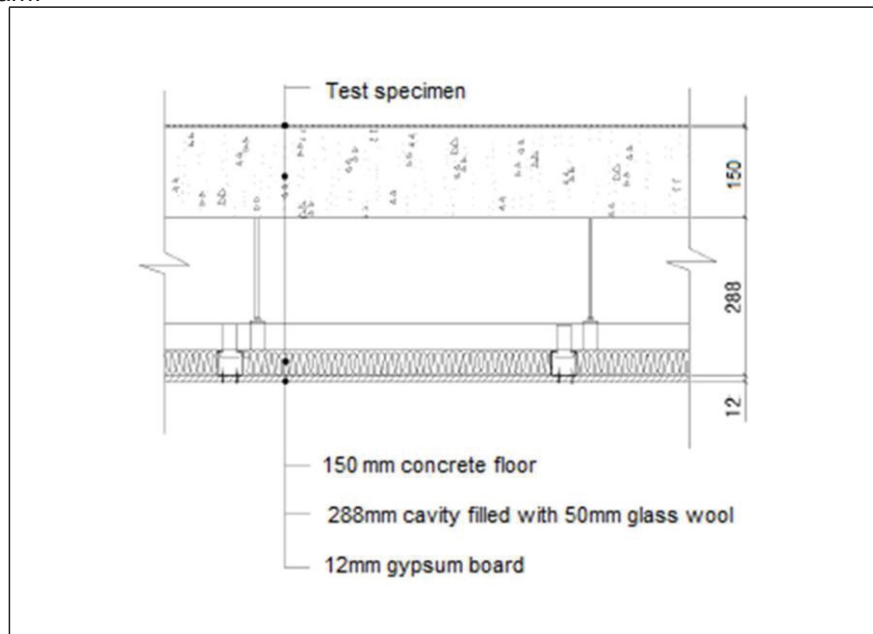
### Schematic diagram:

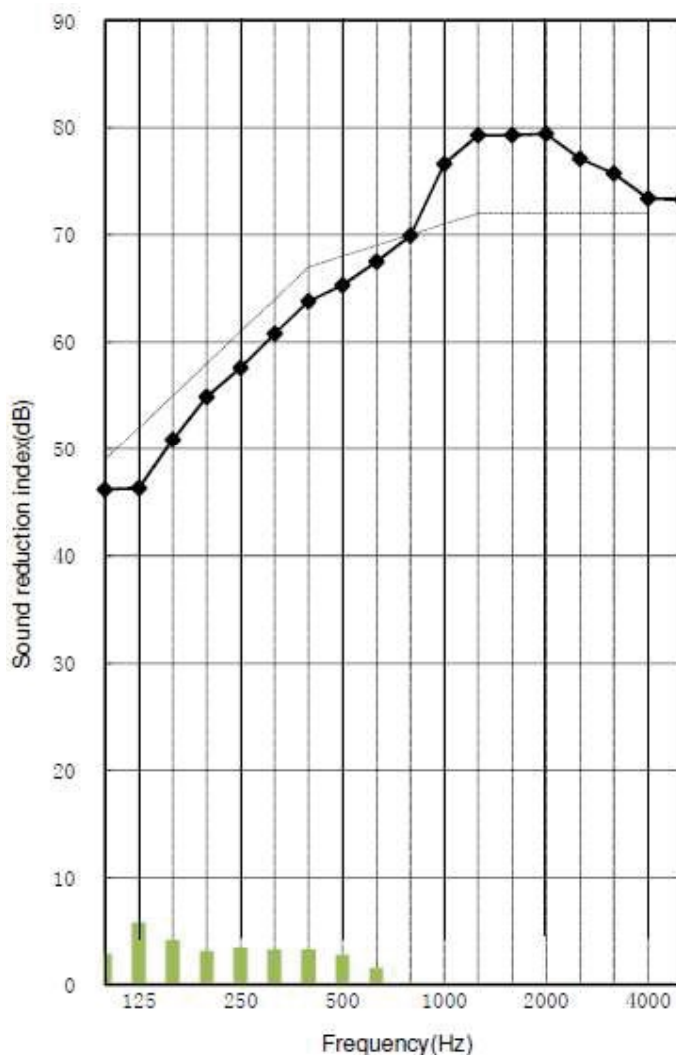
| f<br>Hz | TL<br>dB |
|---|---|
| <b>STC</b> | <b>68</b> |

Remark: TL is the transmission loss.

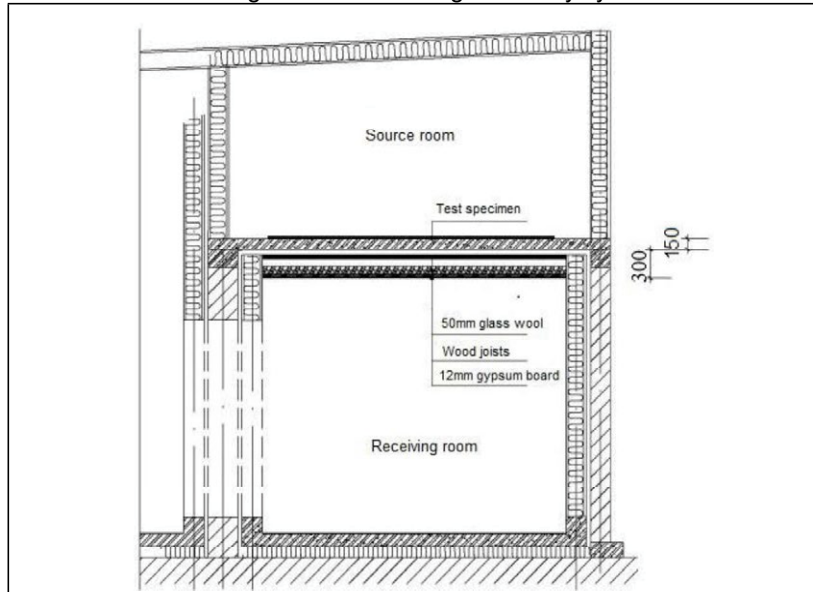
### Appendix 2: The constructional drawing of the floor/ceiling assembly system

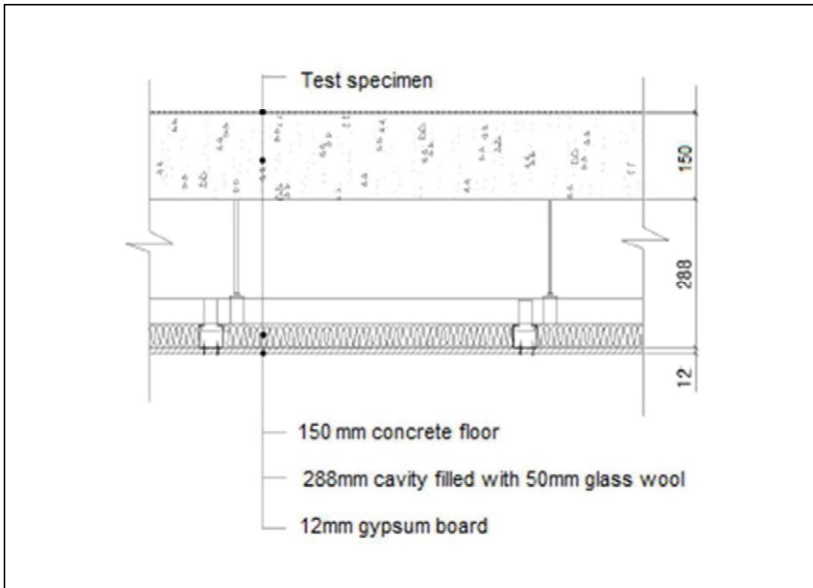
### Schematic diagram:

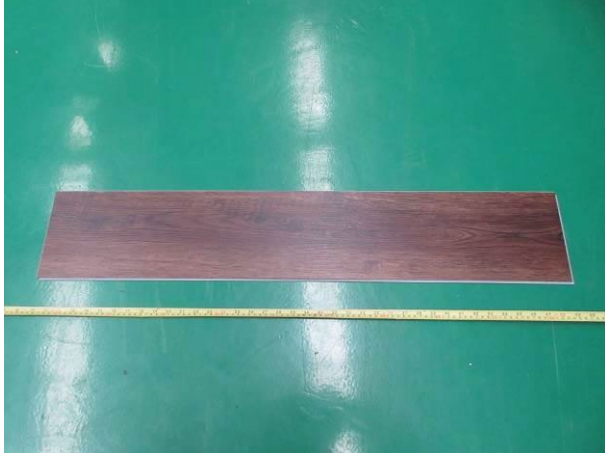
| C.1 Surface view of sample | C.2 Back view of sample |

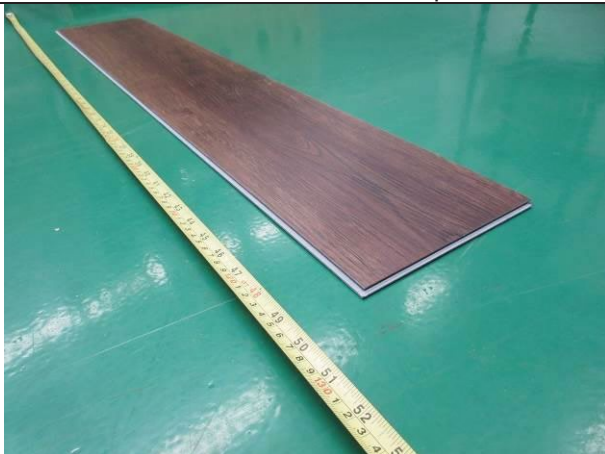
| C.3 Section view of sample | |
