# XPR STUDIO

Rigid core oversized plank

XPR + PAD

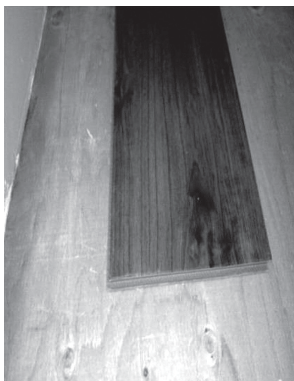
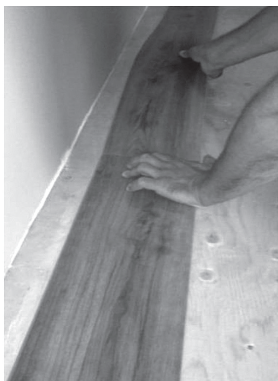
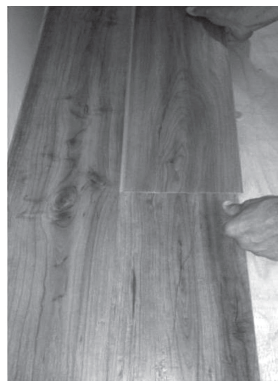
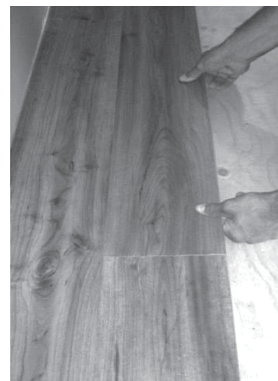
1. Diagram #1: Start with the first plank in the left corner of the room, tongue-side facing out from the wall to the length and to the right on the width. Work from left to right.
2. Diagram #2: Position the following planks as an exact extension of the first one.
3. Cut to fit the last plank of the row. To do this you can use a utility knife to score the surface at the appropriate point and then break the tile over an edge. A laminate cutter or miter saw can be used as well.

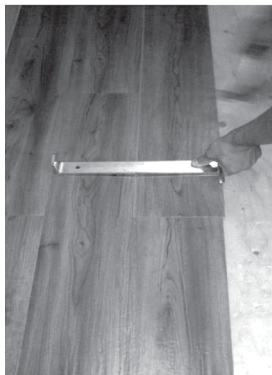
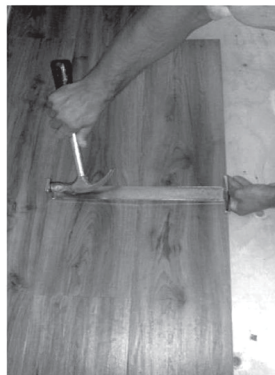
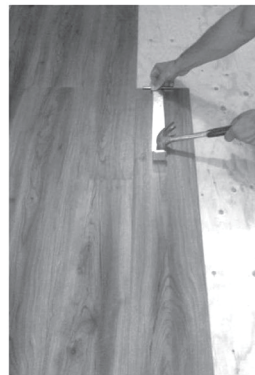
3. Diagram #5, 6 and 7: Raise the plank slightly and push it into the lengthways tongue, first close to the front connection, then the rest. Make sure seams are tight on ends and sides using pull bar or tapping block before proceeding. Continue the installation to the last row of sheets, as described.

1. Diagram #3: Begin the second row with the cut-off end to start the next and subsequent rows. Allow at least an 8" stagger for the end seams. For positioning the planks together, starting with the first tile in the row, raise the plank at a 45-degree angle, insert the lengthways tongue into the lengthways groove and lower the plank while holding the two together until they are flat and tightly together. Close the joint using hand pressure, tapping block or pull bar.
2. Diagram #4: Lever the next sheet in place from the front side so that only a very short distance remains for it to be pushed into the lengthways connection.

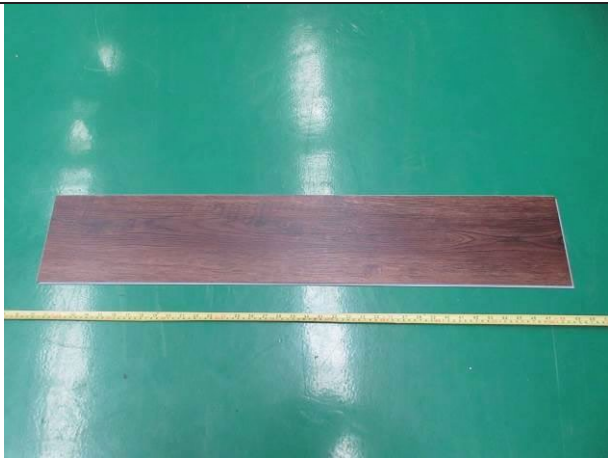
| C.1 Surface view of sample | C.2 Back view of sample |

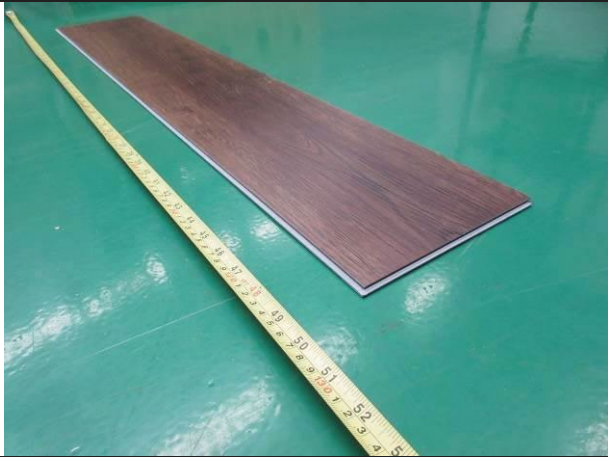
| C.3 Section view of sample | |
